Housby Auctions (Marcus Bowersox)  
4747 NE 14th St, Des Moines, IA 50313 USA  
(515) 299-6265

VIN: 1FVMAQL94DN31270  
Stock #: 56.0196

## 2004 FREIGHTLINER FLD120SD WITH REAR MIXER

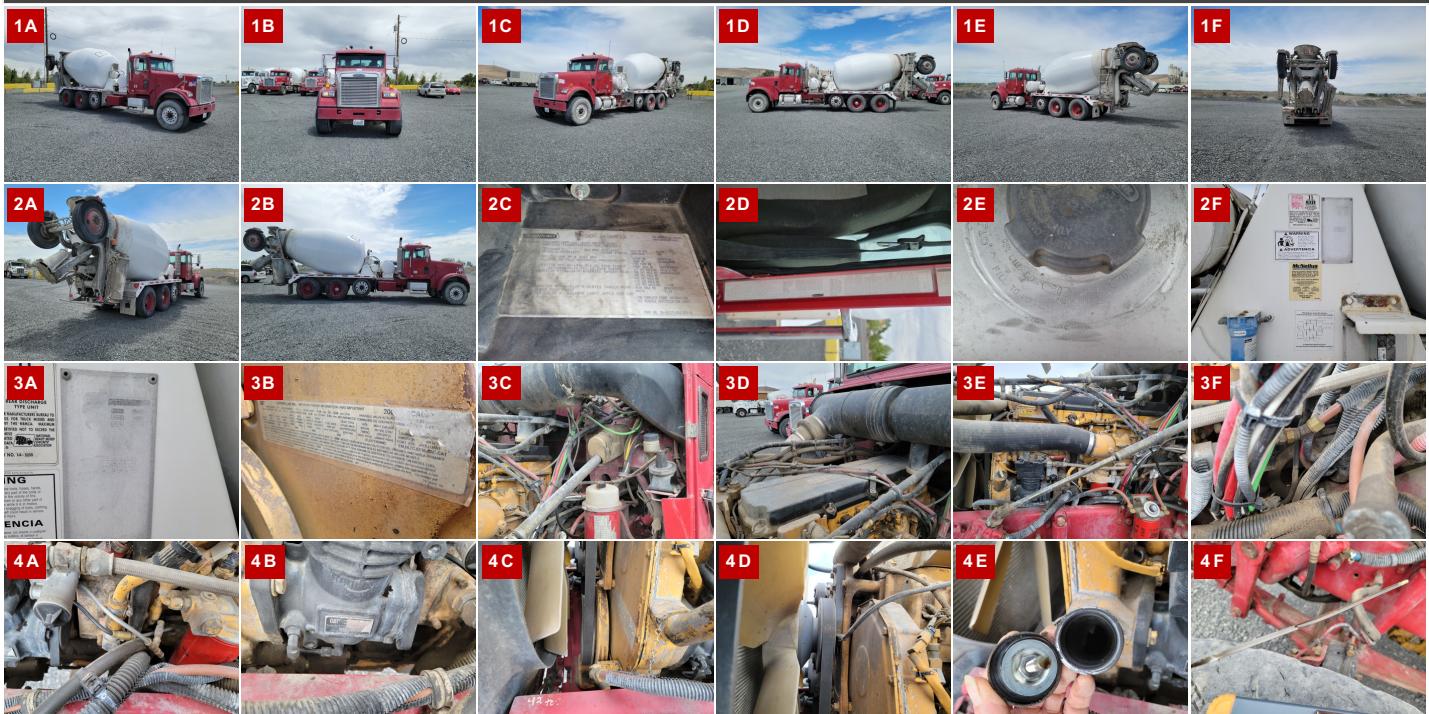
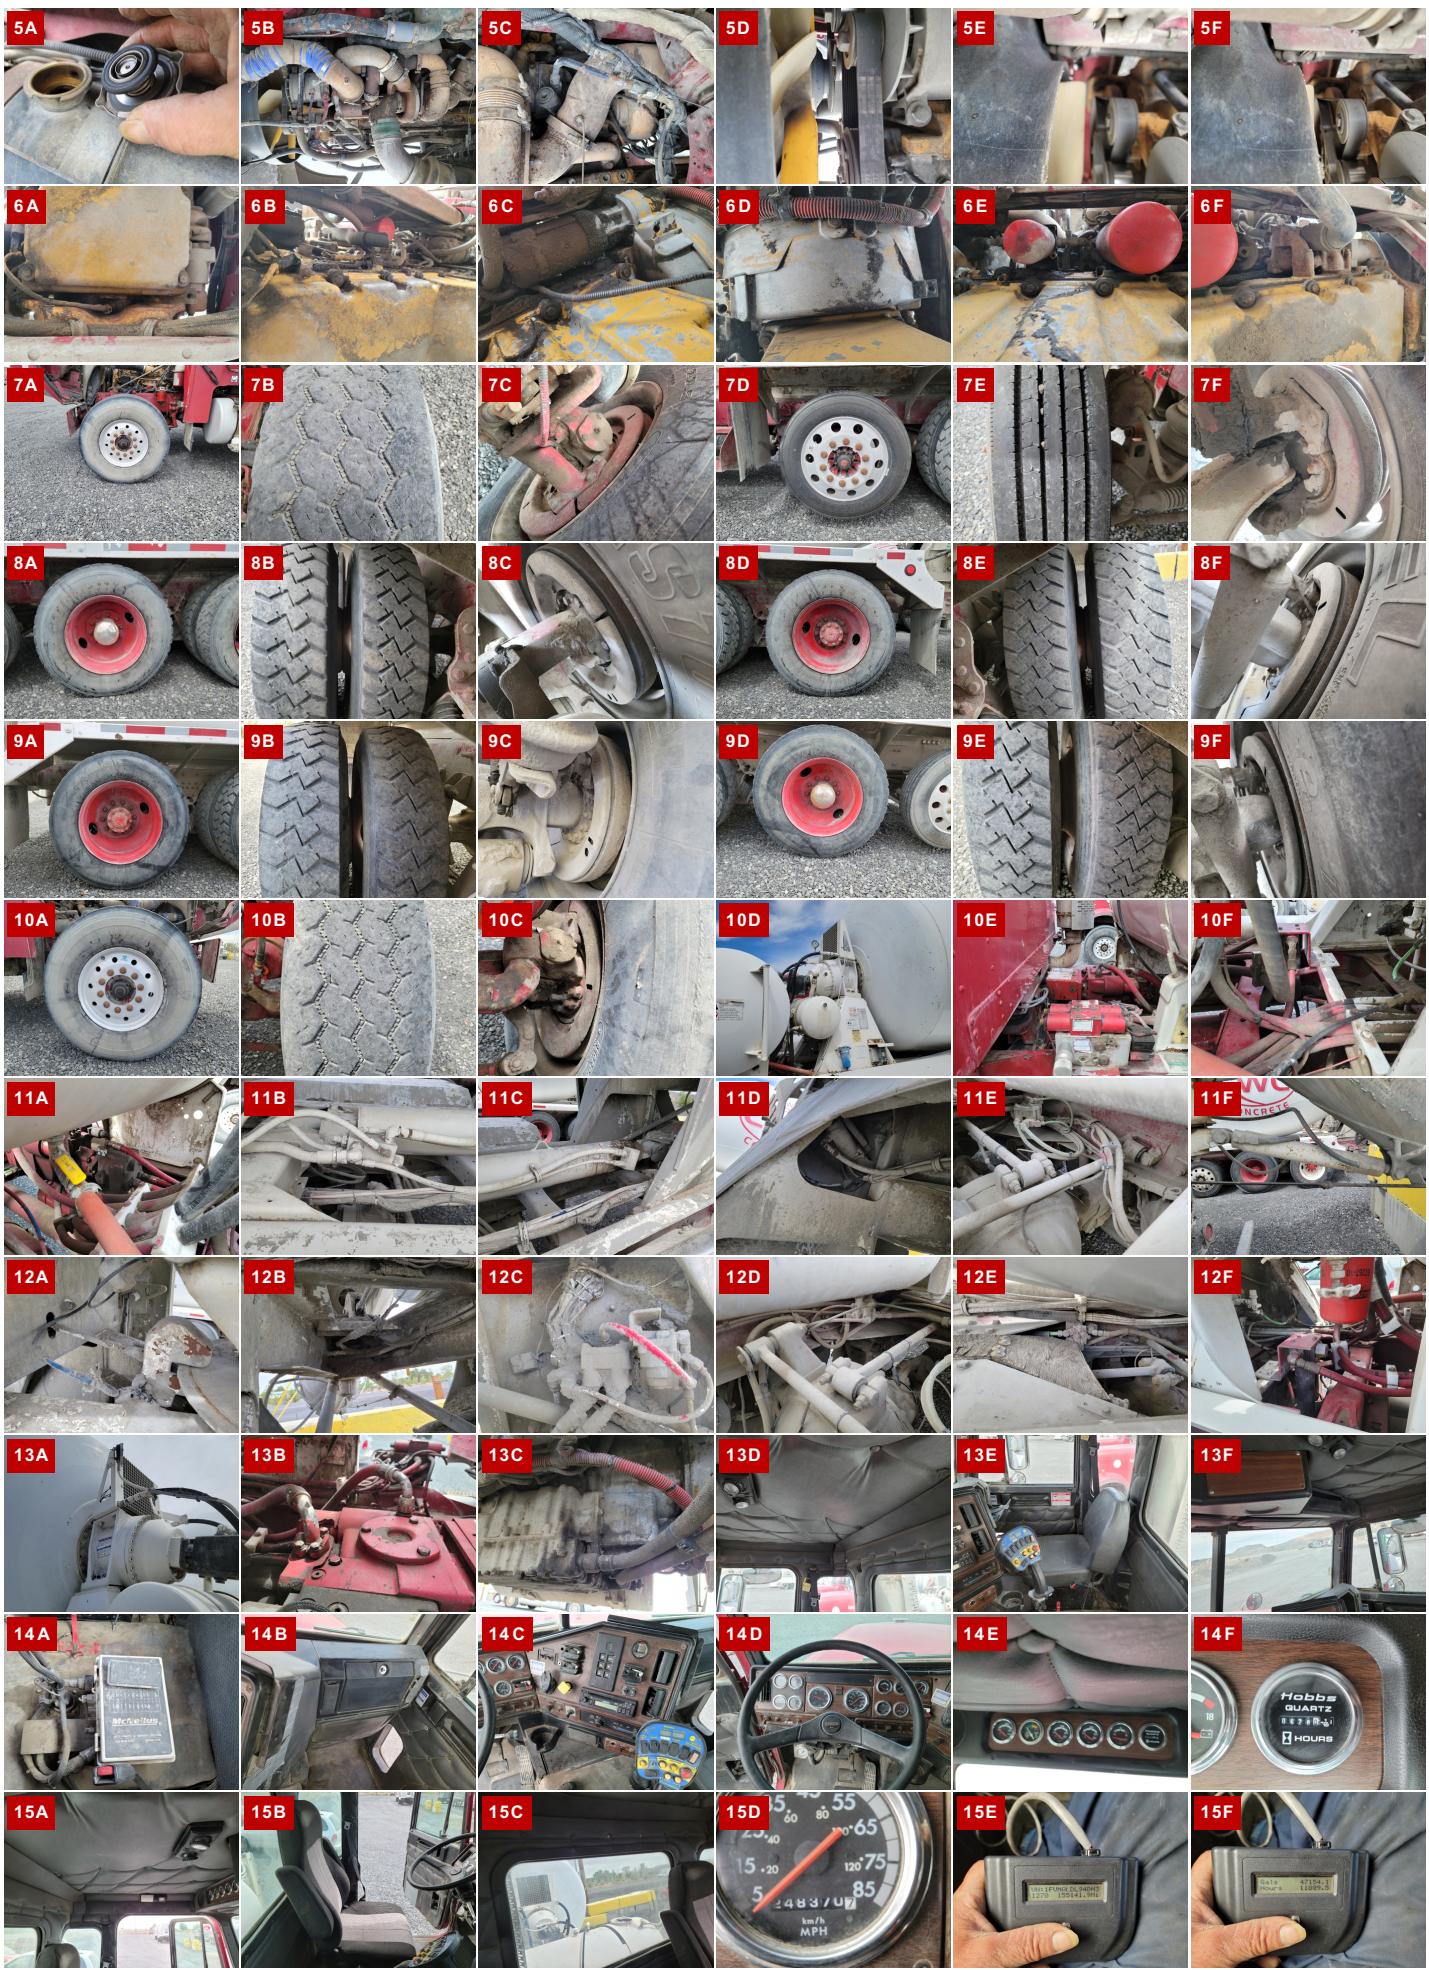
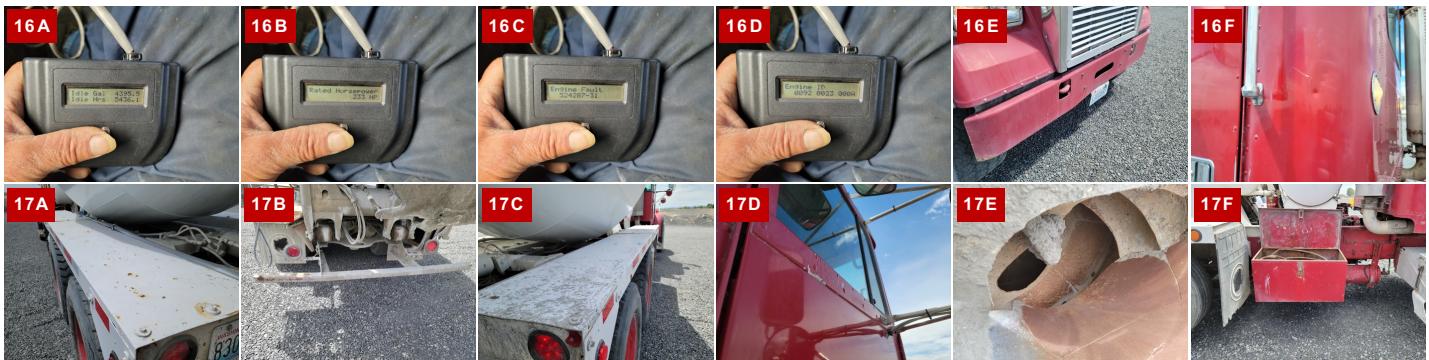
#### REPORT PHOTOS

FUEL GAUGE SHOWS EMPTY, TACH DOES NOT ZERO WHEN ENGINE IS OFF, LEFT TURN INDICATOR ON DASH DOES NOT ILLUMINATE. RESIDUE NOTED AT BOTTOM OF BLOCK / OIL PAN.

DIAGNOSTICS	ENGINE 524287-31
CAB	SMALL DENTS BEHIND DRIVERS DOOR, PAINT BUBBLED ON PASSENGER DOOR
REAR FENDERS	PAINT CHIPPED
DASH	DAMAGED PASSENGER SIDE
TIRES	4 BELOW 10/32'S
BUMPER	FRONT AND REAR BENT
PAINT	VARIOUS CHIPS, SCRATCHES AND PEELING
MUD FLAPS	DAMAGED / MISSING
HEADLINER	LOOSE
TRANSMISSION	RESIDUE NOTED
DRUM	DENTED
