Housby Auctions (Ashly Healey)
4747 NE 14th St, Des Moines, IA 50313 USA
(515) 299-6265

VIN: 2FWJA3DE87AY55679
Stock #: AZTK10

2007 STERLING A9500

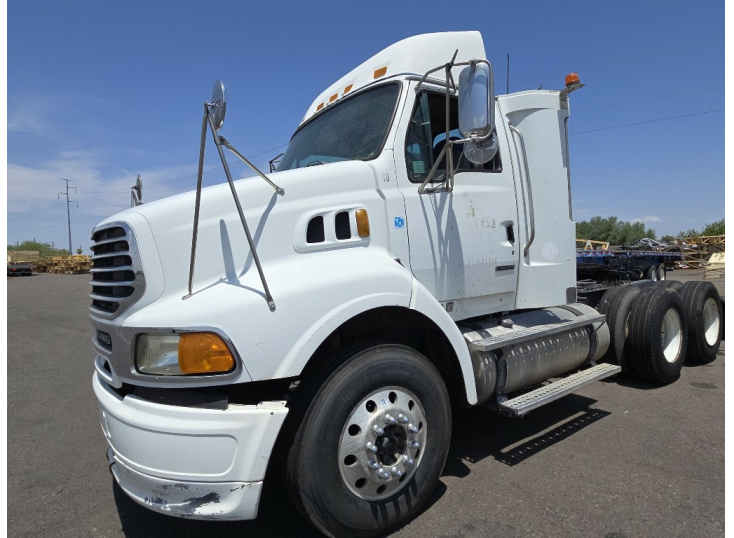
SPECIFICATIONS	
MILEAGE	929,963 / 393,448 (ECM)
ENGINE HOURS	14,168
ENGINE	CAT C13 12.5L 450 HP
ENG BRAKE	YES
ENG SERIAL	RCB84164
FUEL / TANKS	DIESEL - 2 ALUM 240 GAL TOTAL
EXHAUST	SINGLE
TRANSMISSION	EATON-FULLER FRW-15210B 10 SPD MANUAL
DRIVE OPTS	POWER STEERING, CRUISE
AXLE TYPE	TANDEM - F 12,000 LB / R 20,000 LB
GVWR	52,000
FRAME	STEEL
SUSPENSION	AIR RIDE
TIRE SIZE	11R 22.5
WHEELS	F ALUMINUM / R ALUMINUM
WHEEL 5TH	AIR SLIDE
AIR COND	YES
INTERIOR COLOR	BROWN
MIRRORS	DUAL POWER
HIGH BACK SEATS	DUAL
PASSENGER SEAT	STATIONARY
EXTERIOR COLOR	WHITE
BUMPER	PAINTED
EXTERIOR OPTS	HEATED MIRRORS
