## National Inspection Services

Report: 242605

VIN: 1GBT8C4C26F426553  
Stock #: AR1929

### 2006 CHEVROLET C8500

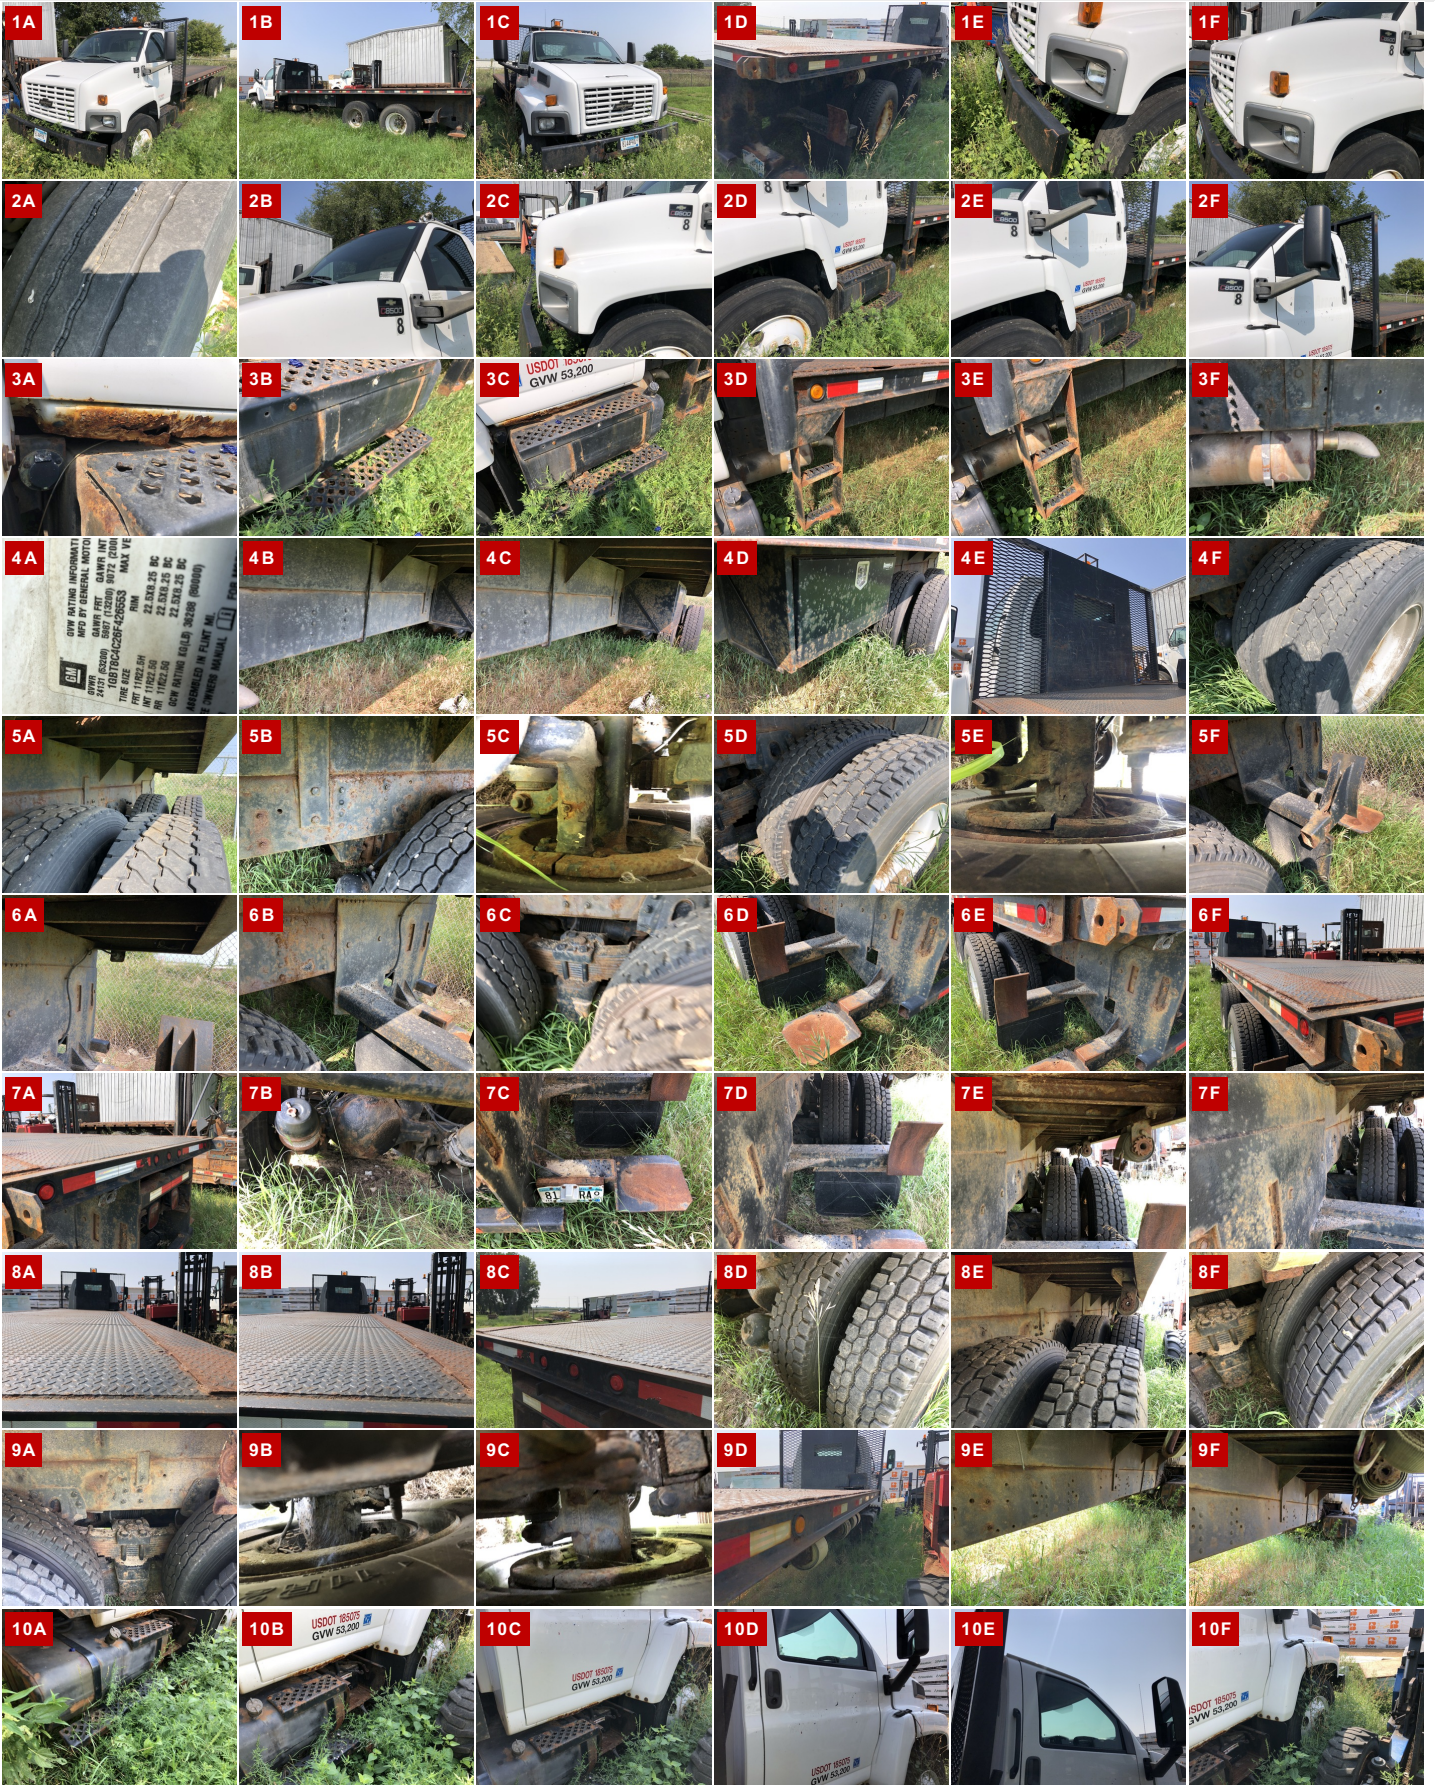
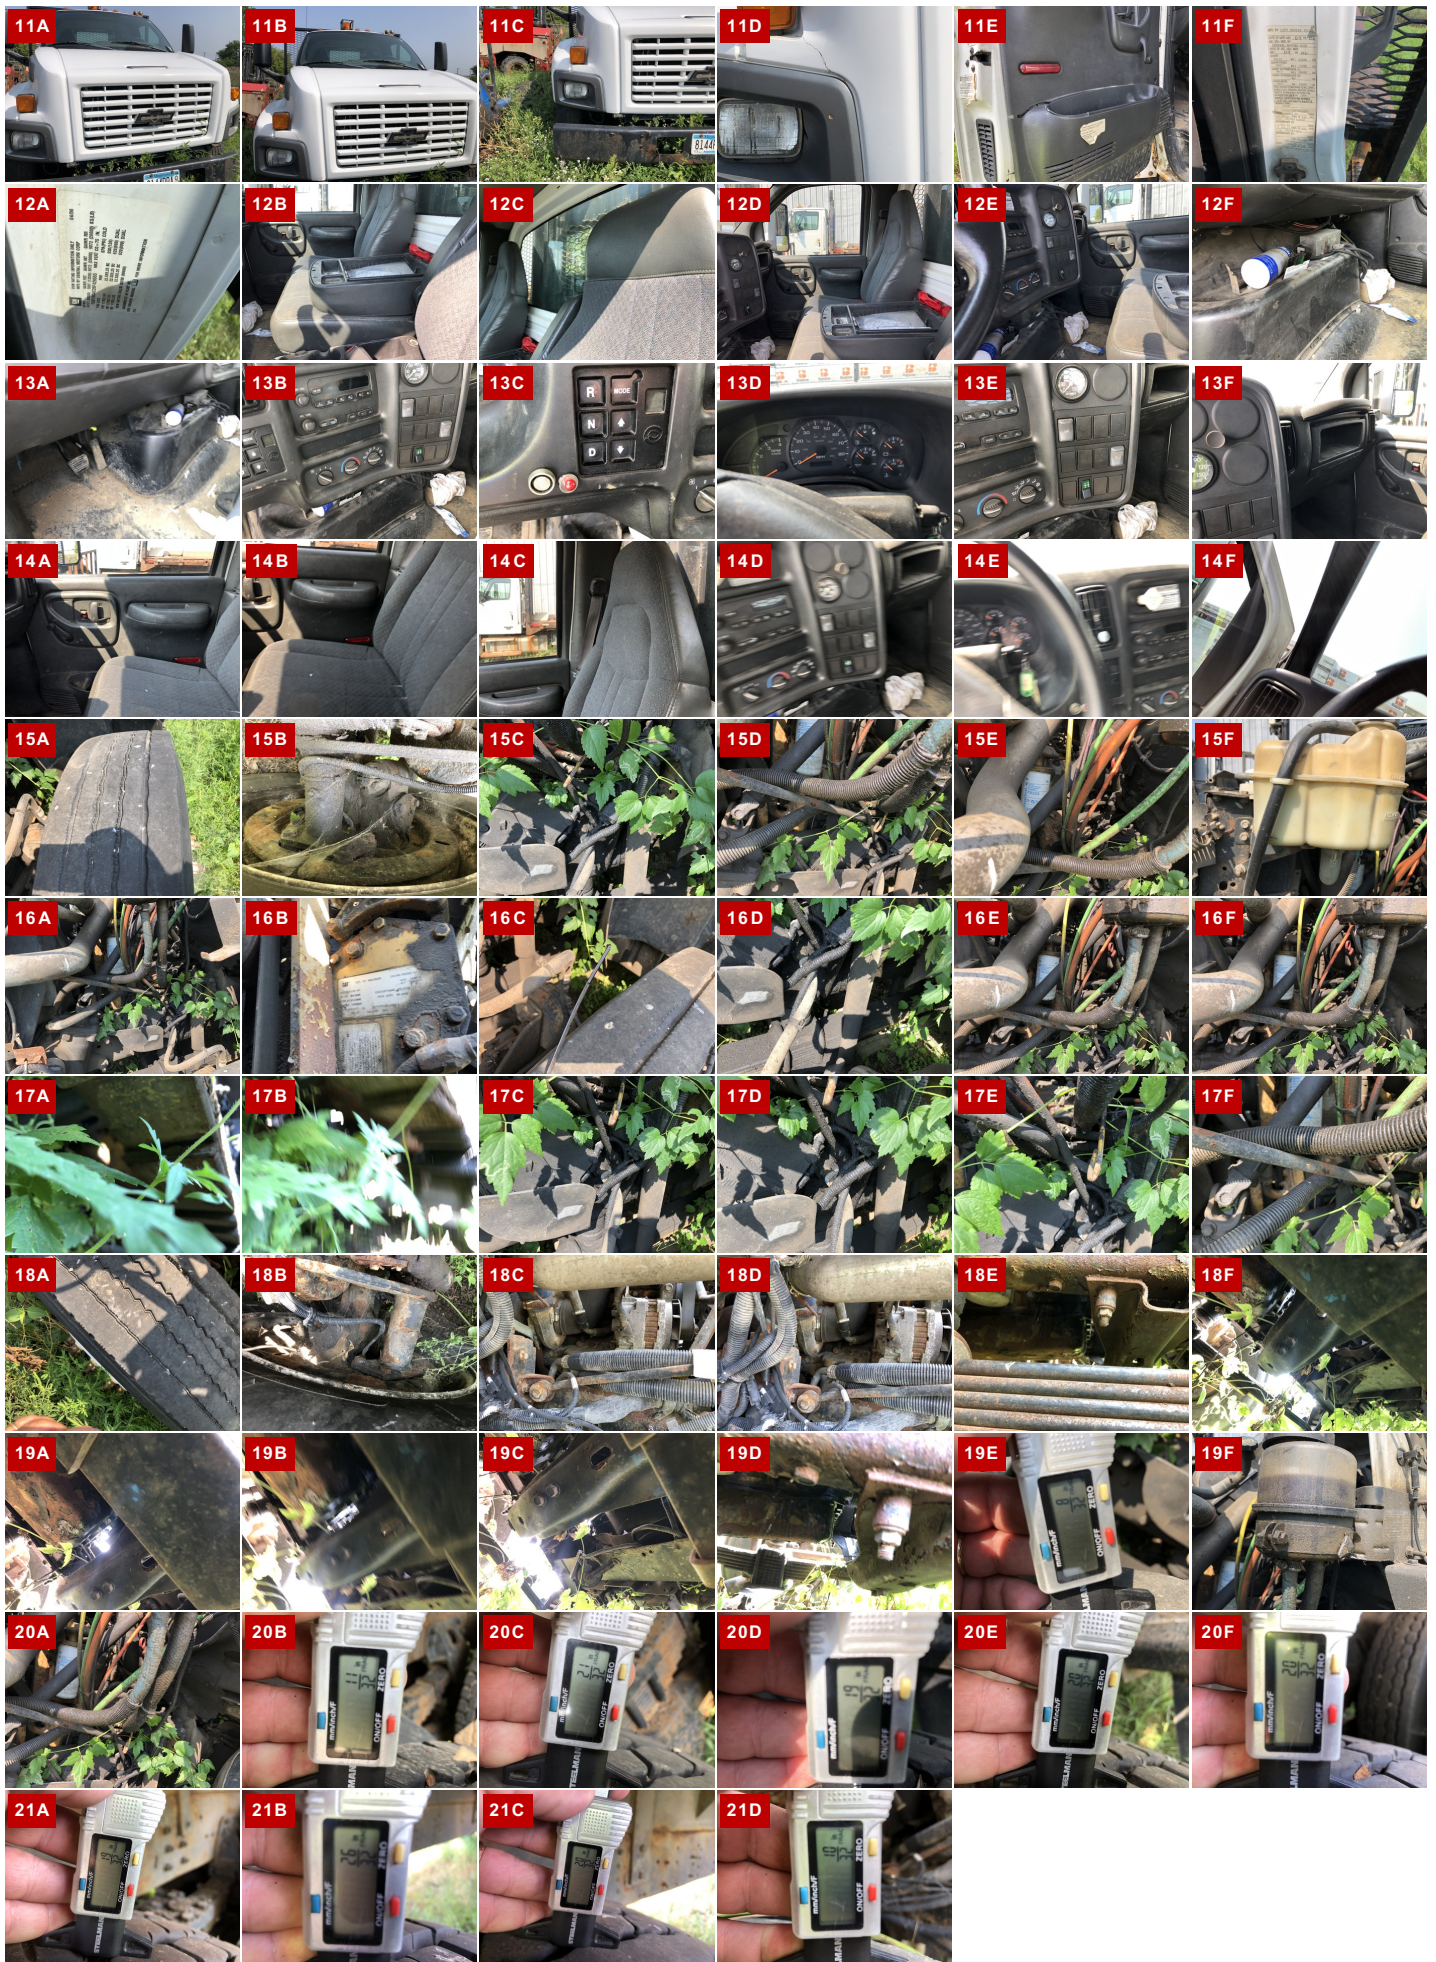
REPORT PHOTOS

MISSING BATTERIES. UNABLE TO OPERATE. OIL LEAKING AT ENGINE AND OIL PAN

| <b>RUST</b> | CAB, BED, FRAME, WHEELS, EXHAUST, FUEL TANK, STEPS, SUSPENSION |

| HOOD | CRACKED ABOVE RIGHT HEADLIGHT |
