National Inspection Services  
# : **117003** on 02/01/2015  
VIN: **4V2JCBPE7SR837610** Unit: **T1905**

## 1994 VOLVO WG64T

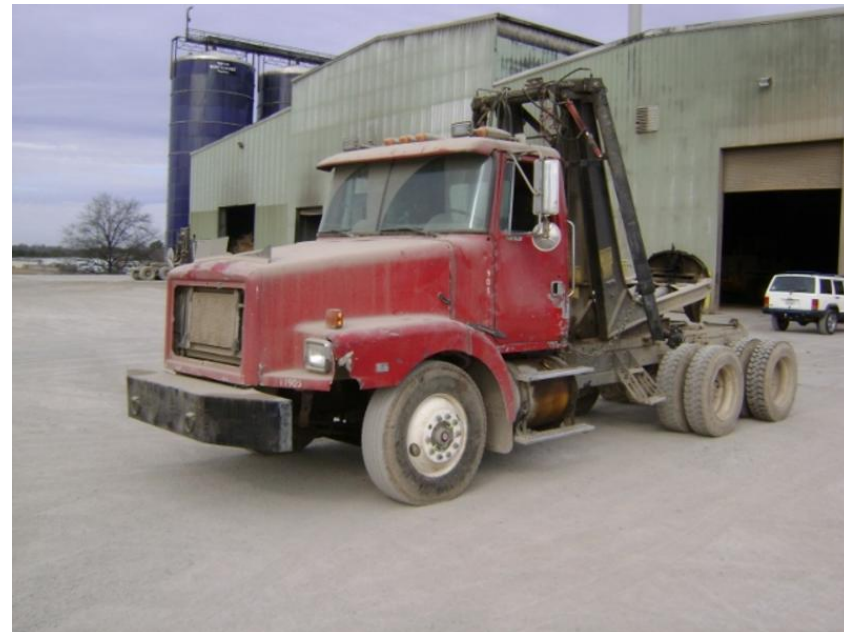
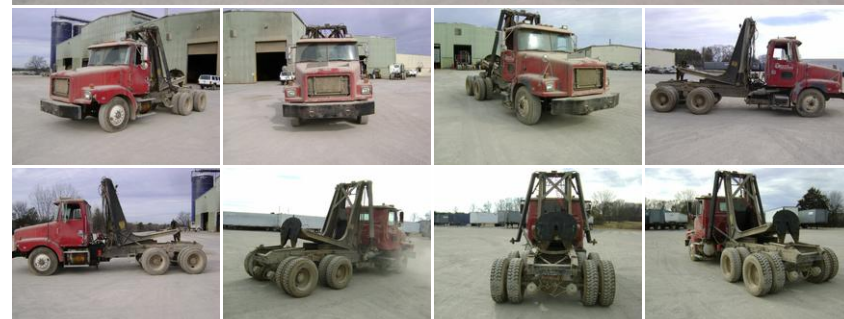
## Power Steering

1994 Volvo tandem axle road truck converted to a yard dog for jockeying trailers, drop and hook. Unit has hydraulic mechanism mounted to frame. Truck is in poor condition and operates with a broken primary frame of lift.

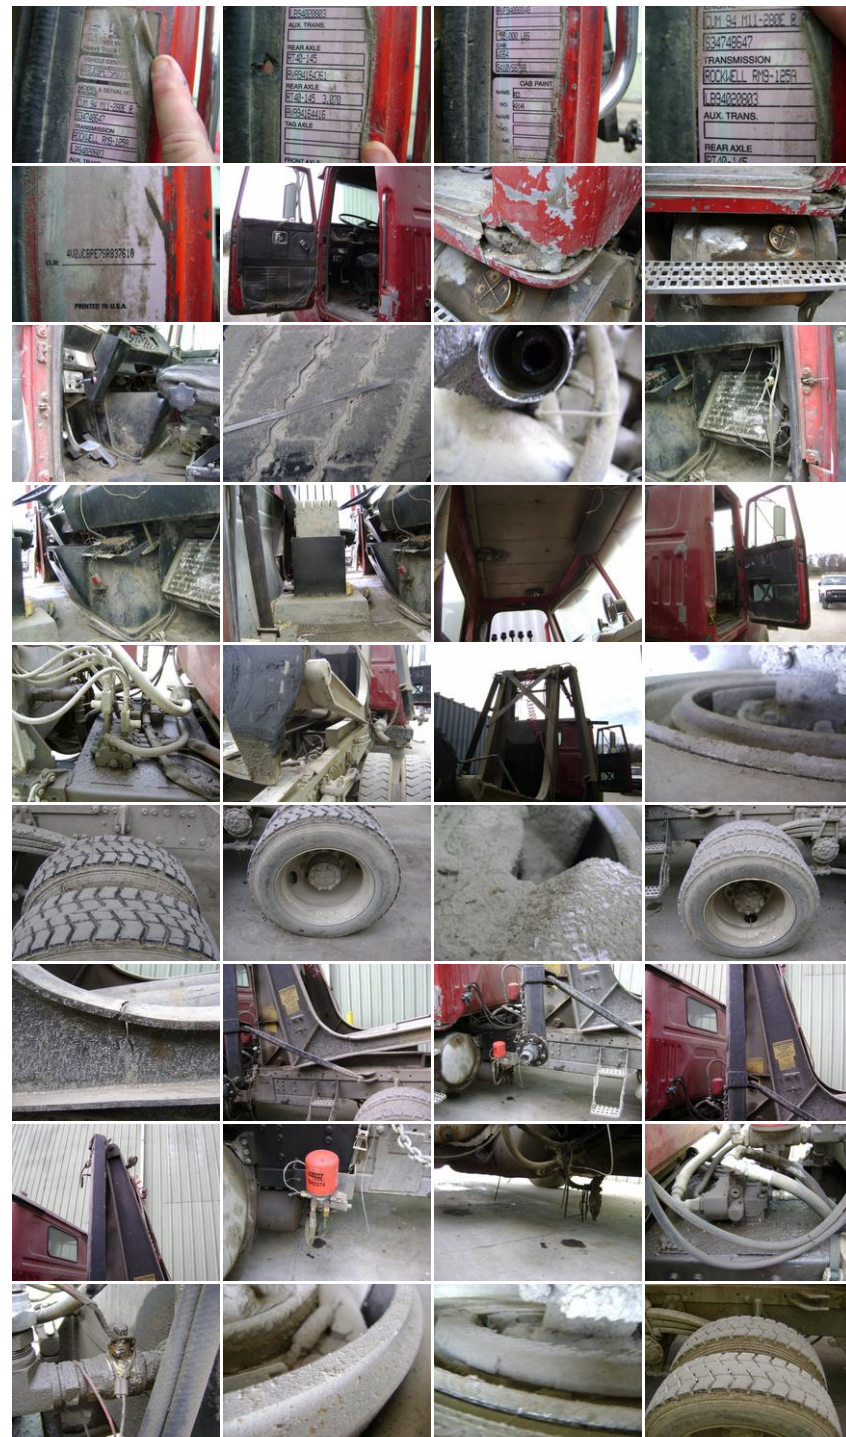
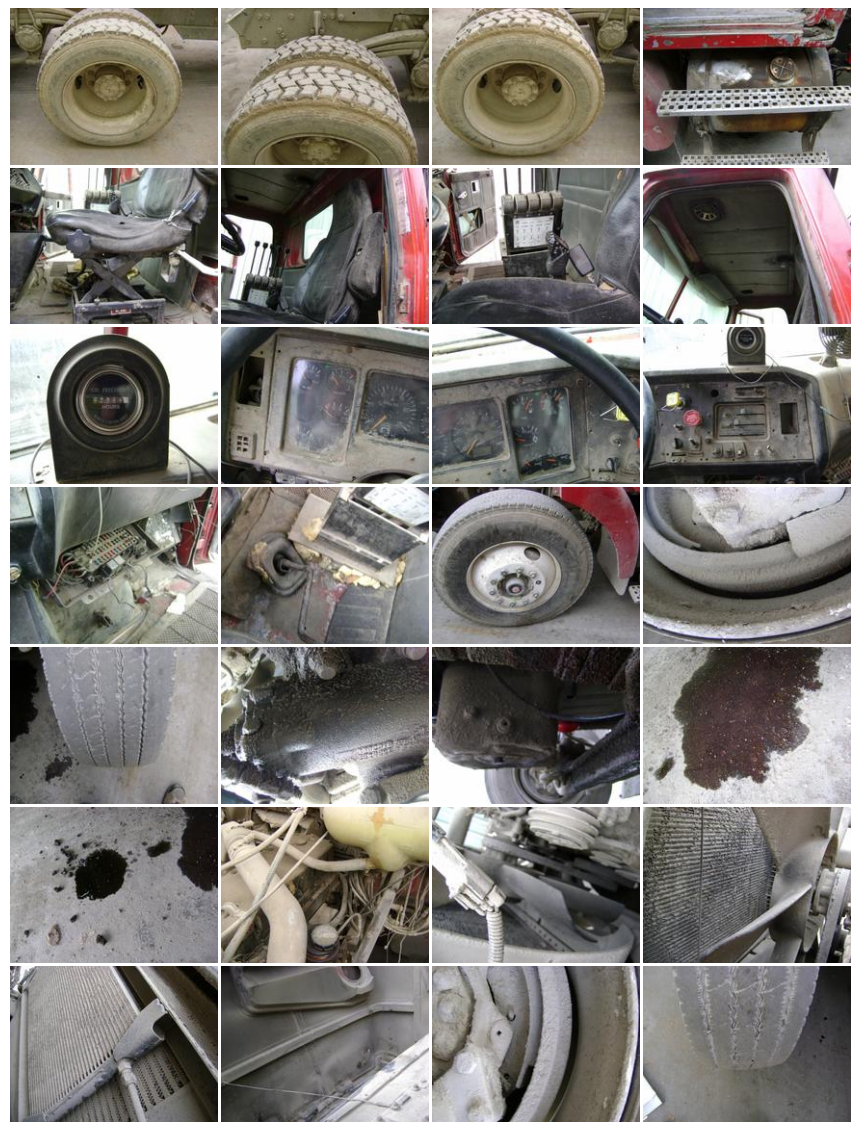
| Wear and Tear Items | | |
|---|---|---|
| Frame | Trailer lift frame is broken | NA |
