National Inspection Services  
# : **117293** on 02/14/2015  
VIN: **1M2P264C7RM015788** Unit: **233**

## 1994 MACK RD690S

### RD690S Specifications

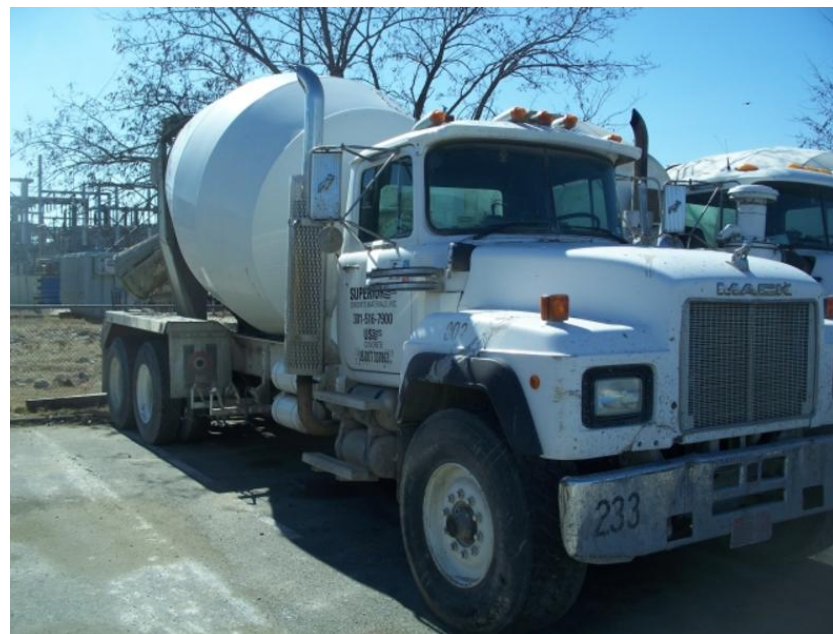
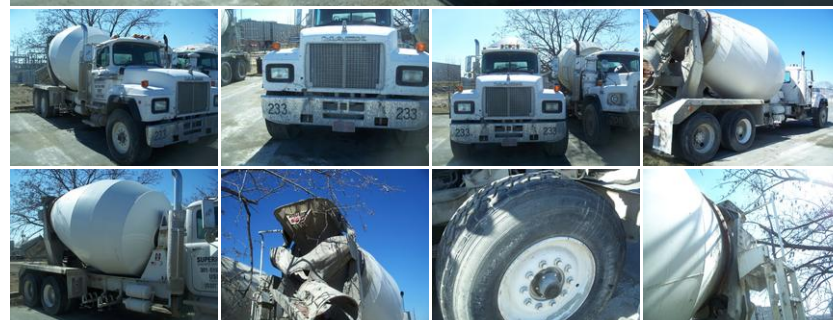
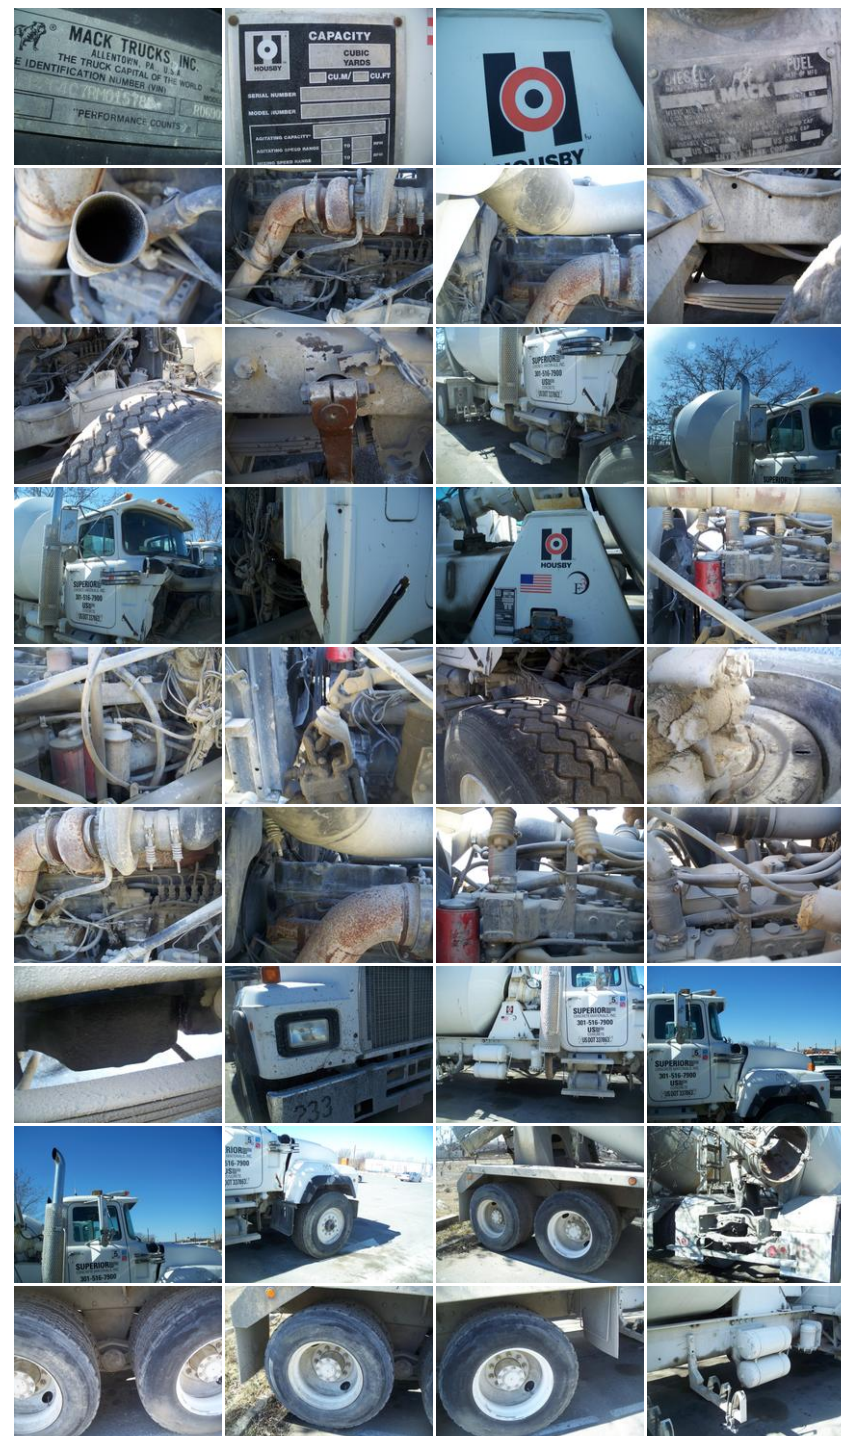
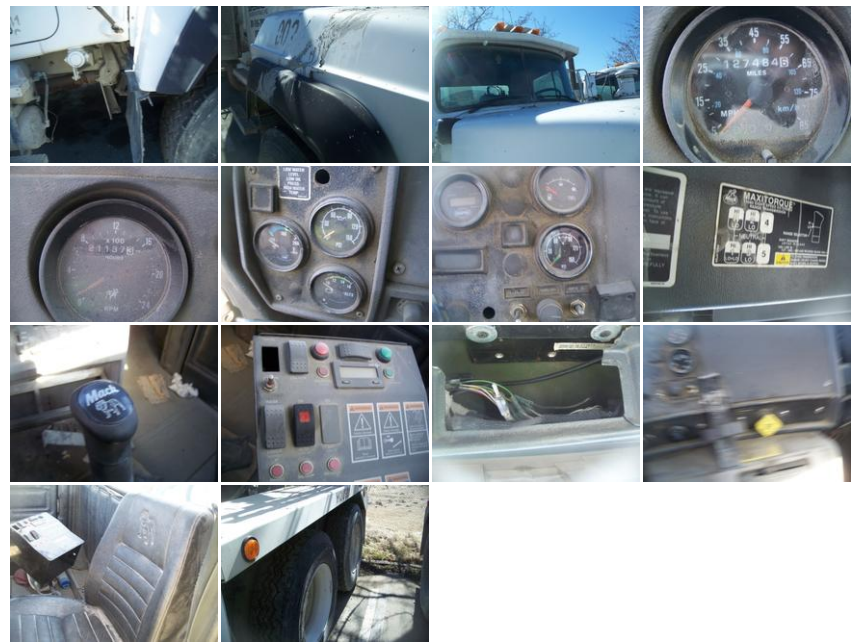
### Inspection Photos

General Observations	
Oil Milky? No	Oil Leaks? No
Water Leaks? No	Oil in Coolant? No
Clutch Play? NA	Starts? No
Drives? No	
Safety / Operational Observations	
Lights Work? Yes - All	Wipers Work? Yes
Gauges Work? Yes - All	City Horn Works? Yes
Air Horn Works? See Detail	
Additional Observation Detail	
Truck will not start, no air pressure to check horn

Wear and Tear Items		
oil filler	cap is missing	NA
breather	missing	NA
note	Employee states that Pitman Arm is bad, causing a steering problem. They have not been able to find a replacement	NA
body	10 yard mixer Housby model F3 serial number 0045115788	NA
Note	Truck has no batteries. New batteries were installed to attempt to start truck and jumpers were also attached. Engine would crank slowly but would not fire off.	NA
Water tank	Drivers side water tank strap is broken, tank held on with ratchet strap	NA
A/C	unable to check A/C operation due to vehicle not starting	NA
Note	low back driver's seat. no passenger seat	NA
Note	There is no specification tag on the body unable to get axle specs	NA
Engine	ID plate unreadable	NA
Total Estimate		NA
