Housby Auctions (Marcus Bowersox)
4747 NE 14th St, Des Moines, IA 50313 USA
(515) 299-6265

VIN: 1D7HA18N48S563323
Stock #: 01.704896

2008 DODGE 1500

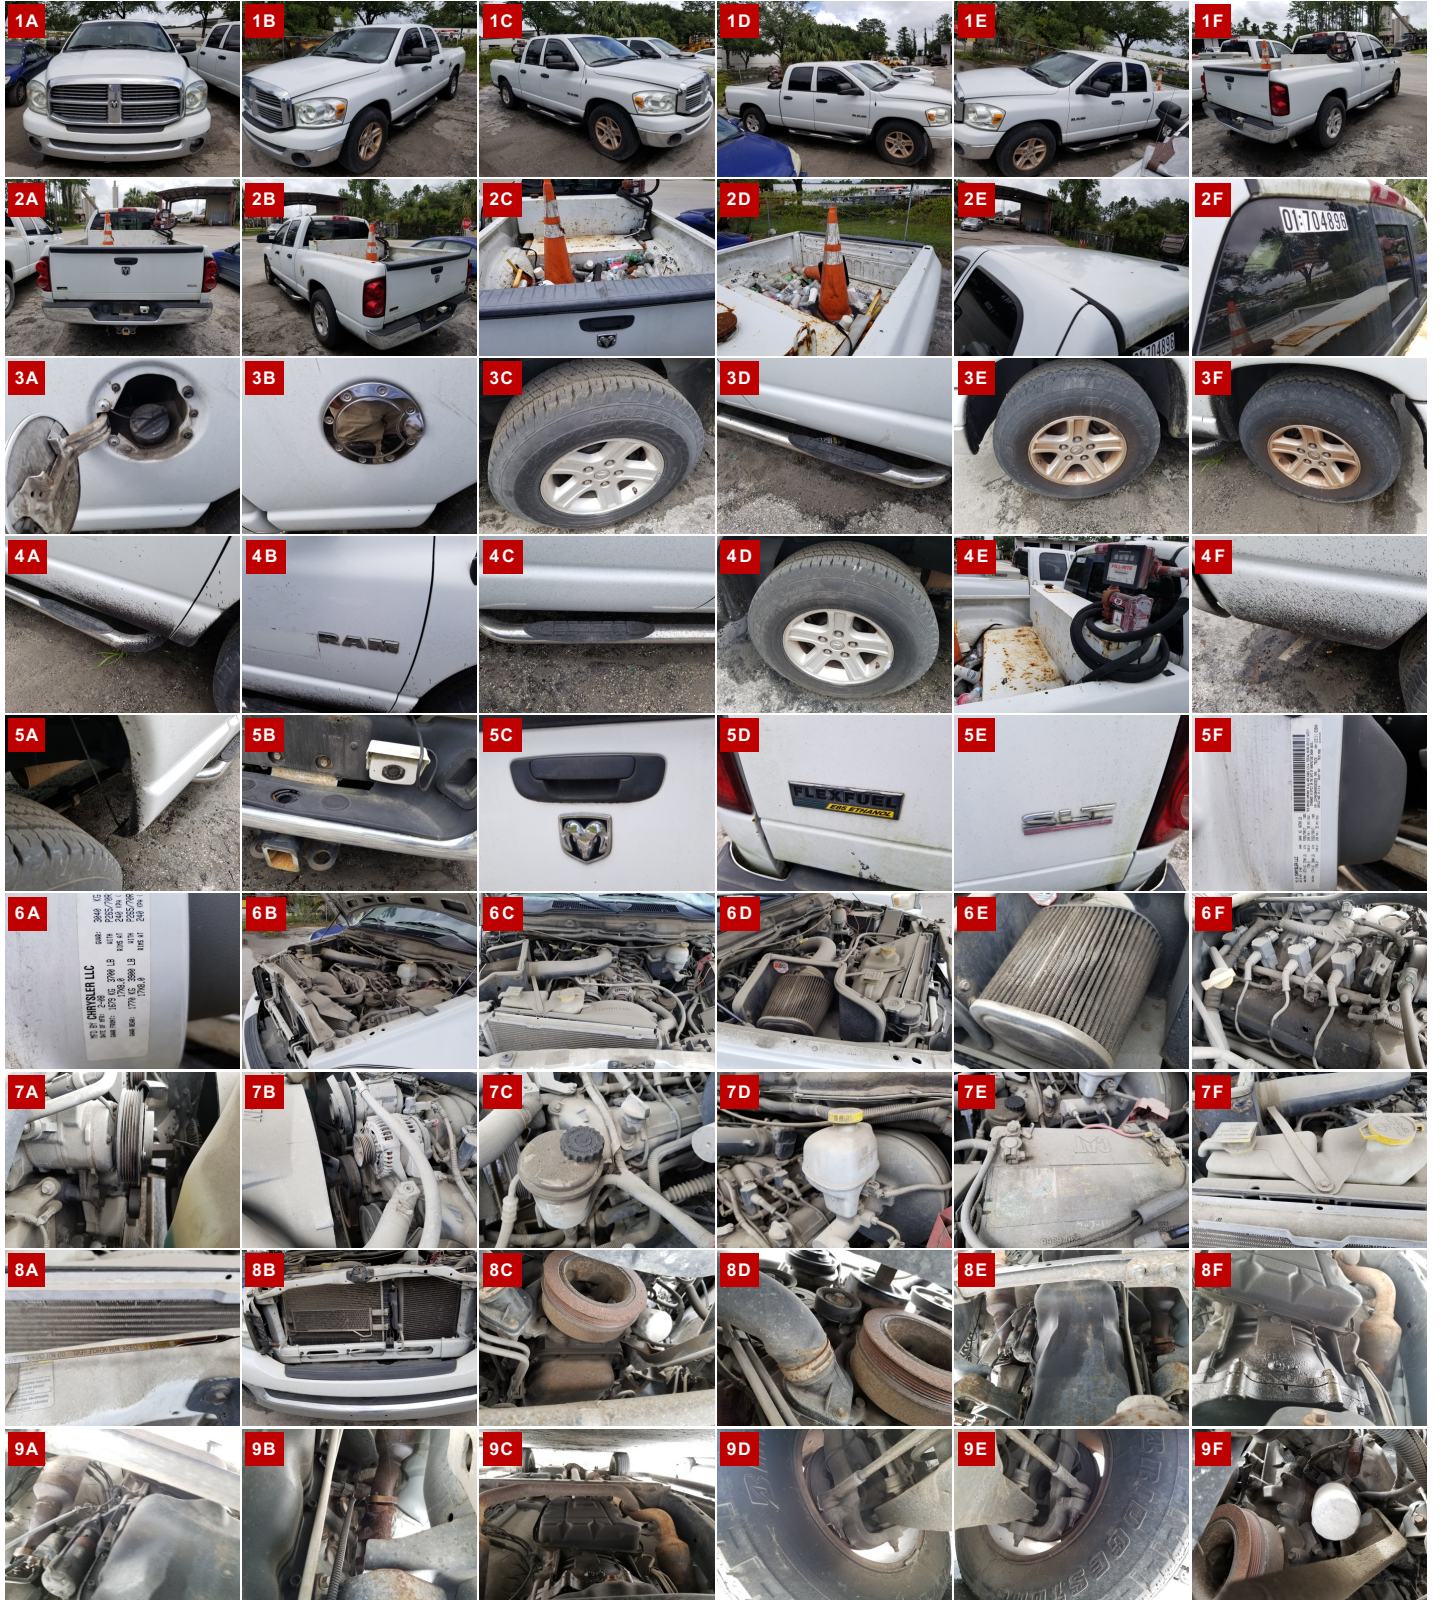
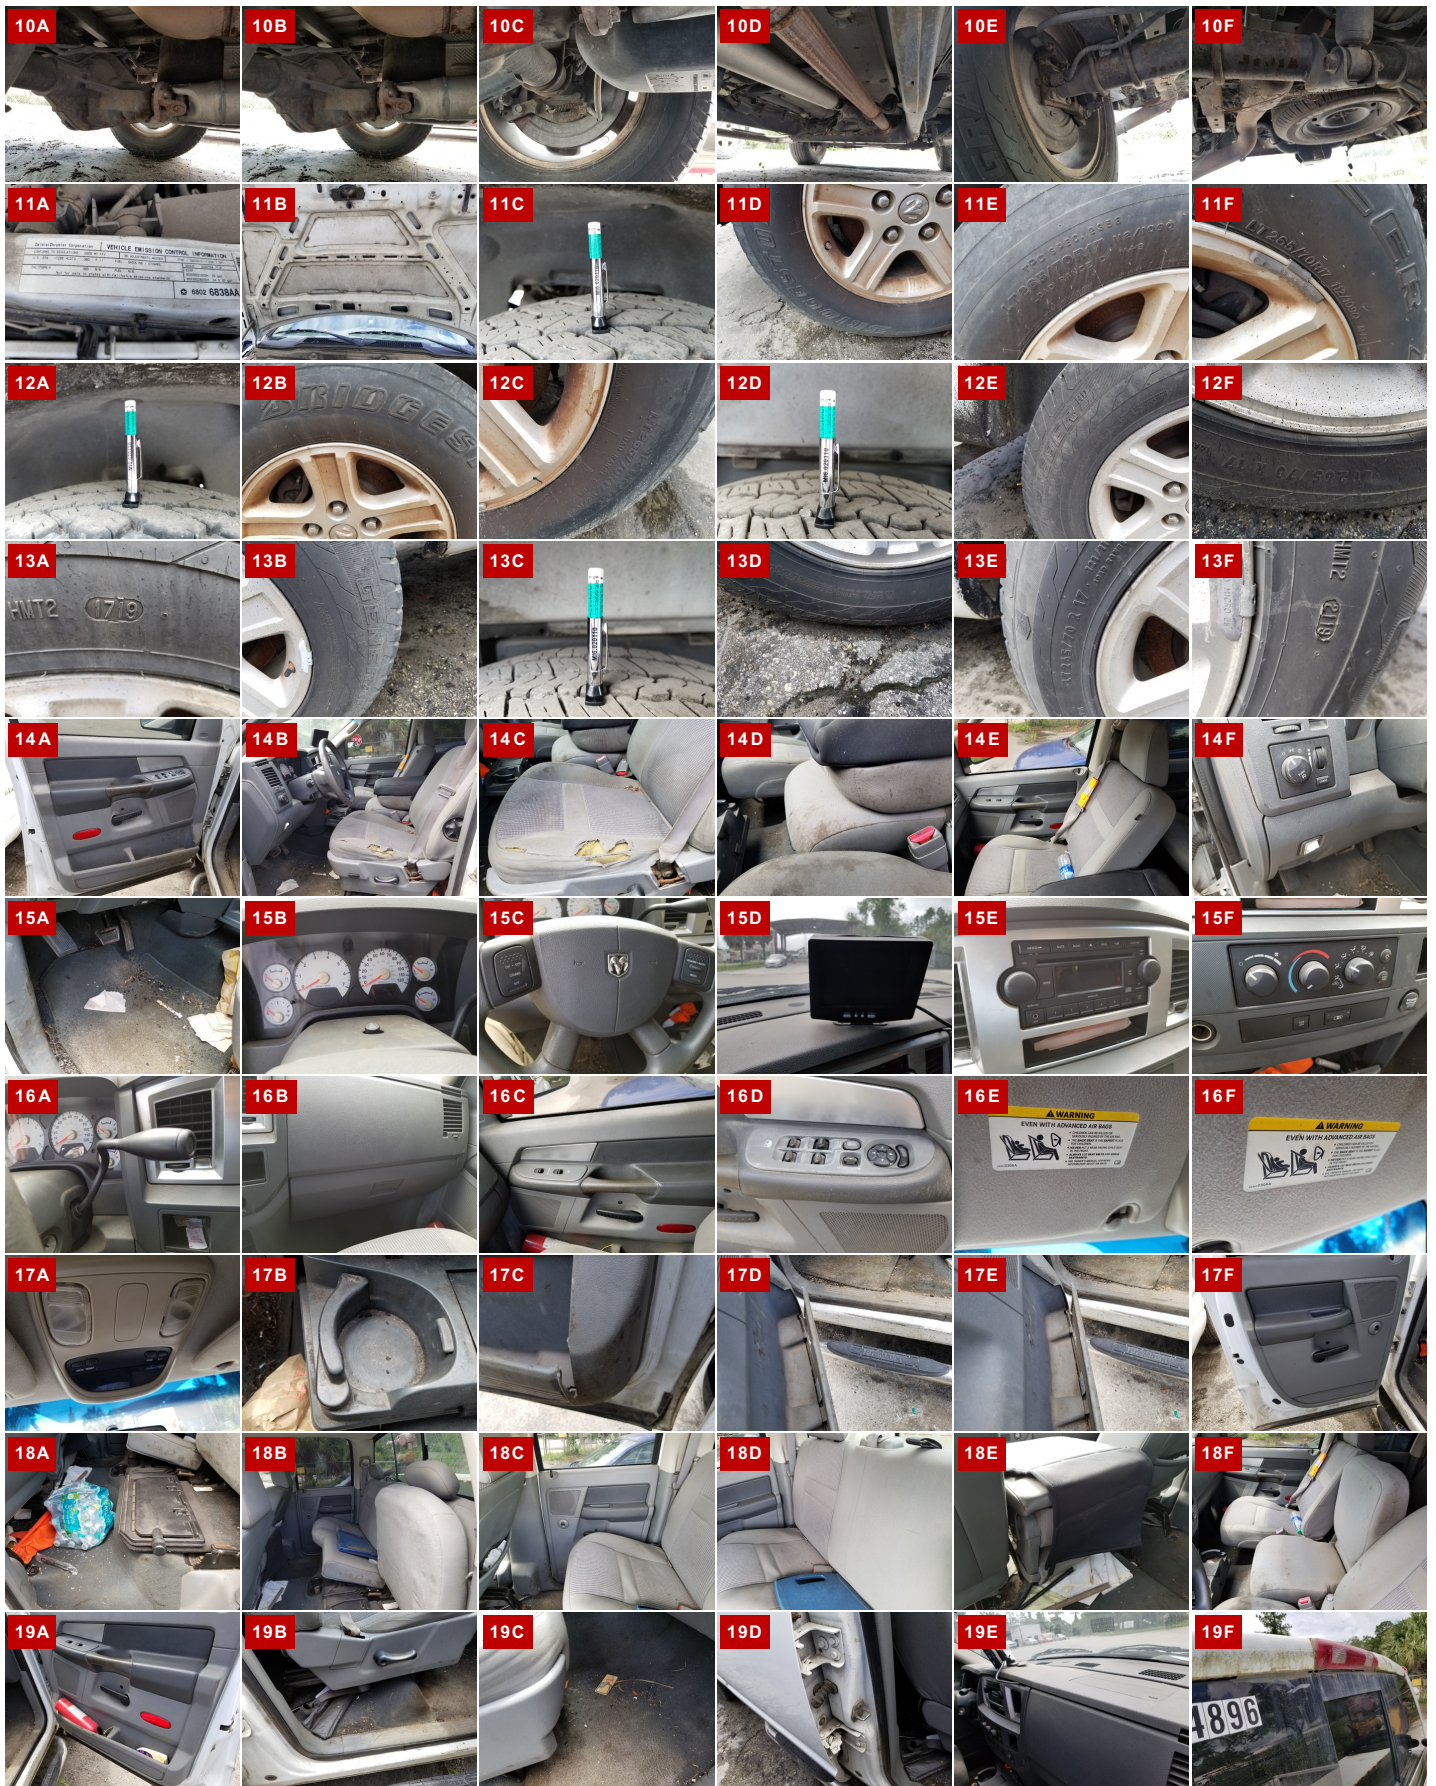
REPORT PHOTOS

ADDITIONAL OBSERVATIONS
OIL LEAK NOTED ON LOWER PORTION OF THE ENGINE / BOTTOM OF BLOCK AREA. TRANSMISSION PAN HAS FLUID RESIDUE NOTED.

WEAR & TEAR DETAIL	
BATTERIES	DEAD, UNABLE TO START UNIT OR TEST MOST ELECTRICAL FUNCTIONS
INTERIOR	DIRT, DUST, TRASH, ETC. EVEN MICE POOP IS PRESENT.
DRIVER SEAT	TORN
DOOR PANESL	LEFT SIDE PLASTIC COVER IS BROKEN.
BACK WINDOW	GASKET IS BROKEN, SINGS OF CAULK OR SEALER WAS USED. PROBABLY THERE IS WATER LEAKING.

PAINT (LOWER SECTIONS AND AROUND WHEELS).	ASPHALT IN PAINT
PAINT	VARIOUS CHIPS AND SCRATCHES NOTED THROUGHOUT UNIT
INTERIOR	SURFACES AND UPHOLSTERY ARE DIRTY
SEATS	COVER TORN
ENGINE BAY	MISSING MULTIPLE COMPONENTS
STEERING WHEEL	WORN
DRIVEABILITY	ENGINE CONDITIONS DO NOT PERMIT TO START IT. BROKEN MAIN BELT, RIGHT SIDE COVER IS MISSING A HOSE CONTACT STATED THAT THE ENGINE ALSO POSSIBLY NEEDS A WATER PUMP REPLACEMENT.
TIRES	1 MEASURES BELOW 10/32
